World Trade Center Building Performance Study:

*Data Collection, Preliminary
Observations, and
Recommendations*

FEMA 403 / May 2002

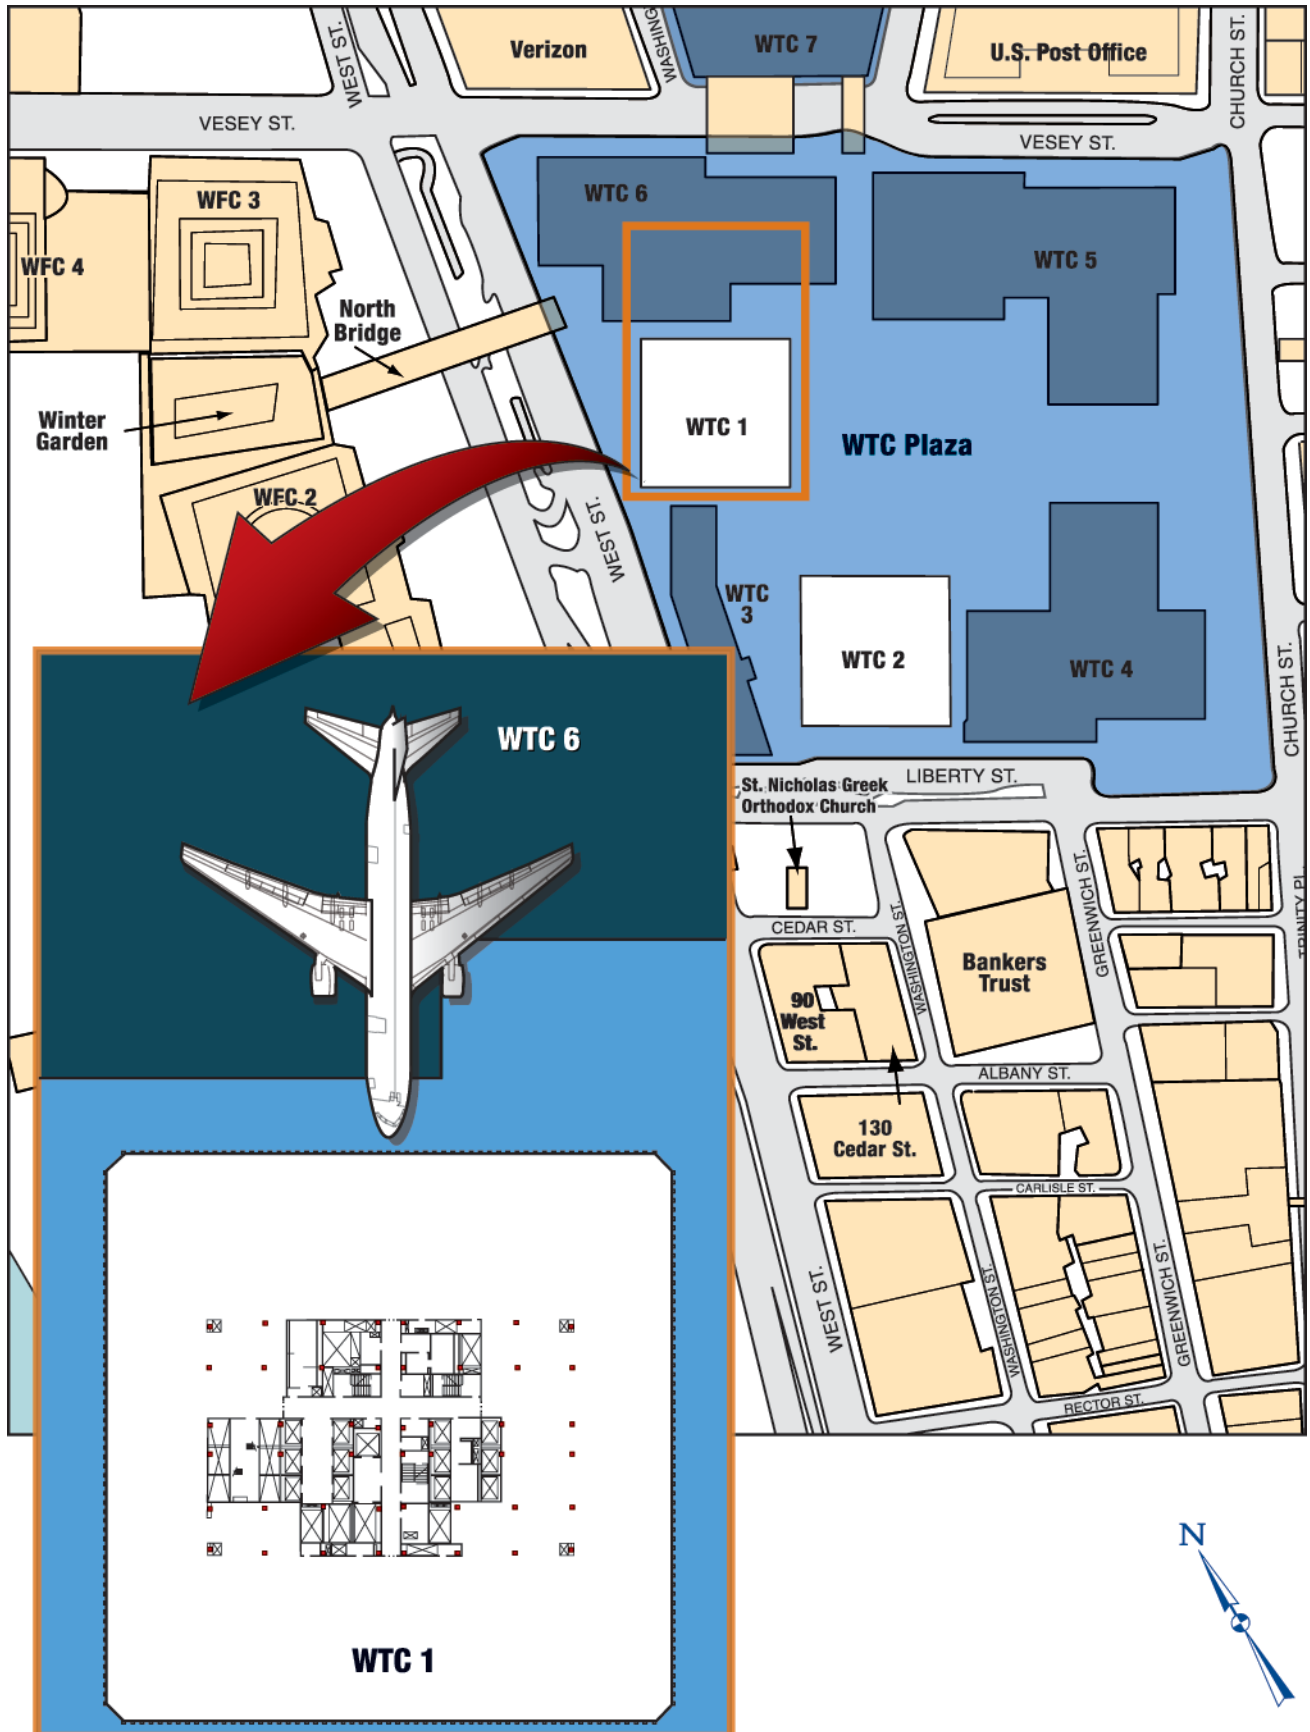
Figure 2-14 Approximate zone of impact of aircraft on the north face of WTC 1.

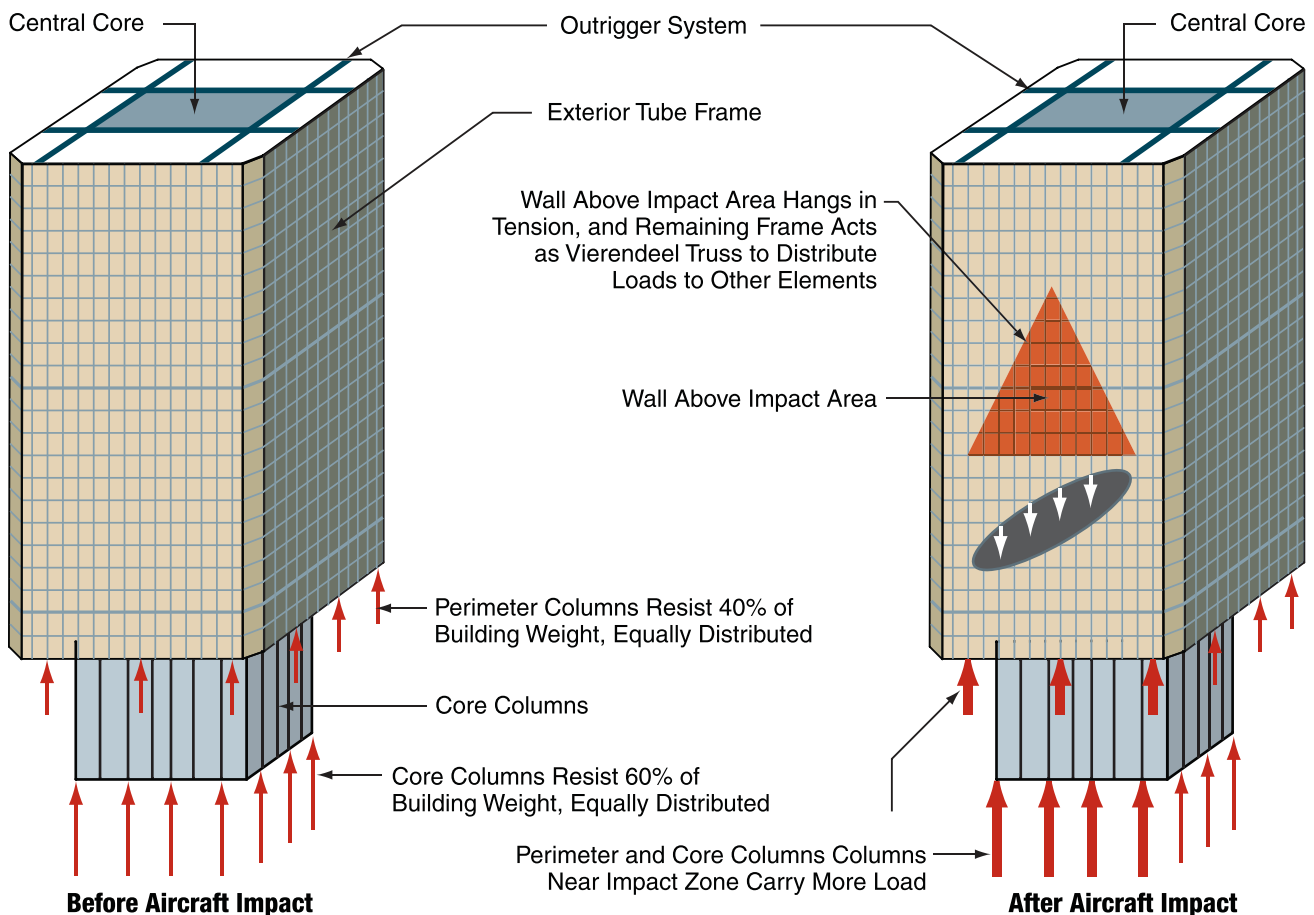
Neglecting the potential loss of lateral support resulting from collapsed floor slabs and any loss of strength due to elevated temperatures from fires, the most heavily loaded columns were probably near, but not over, their ultimate capacities. Columns located further from the impact zone are thought to have remained substantially below their ultimate capacities. The preliminary analyses also indicate that loss of the columns resulted in some immediate tilting of the structure toward the impact area, subjecting the remaining columns and structure to additional stresses from P-delta effects. Also, in part, exterior columns above the zone of impact were converted from compression members to hanger-type tension members, so that, in effect, a portion of the floors' weight became suspended from the outrigger trusses (Figure 2-10) and were transferred back to the interior core columns. The outrigger trusses also would have been capable of transferring some of the load carried by damaged core columns to adjacent core columns. Figure 2-19 illustrates these various secondary load paths. Section 2.2.2.2 provides a more detailed description of these analyses and findings.

Figure 2-19 Redistribution of load after aircraft impact.

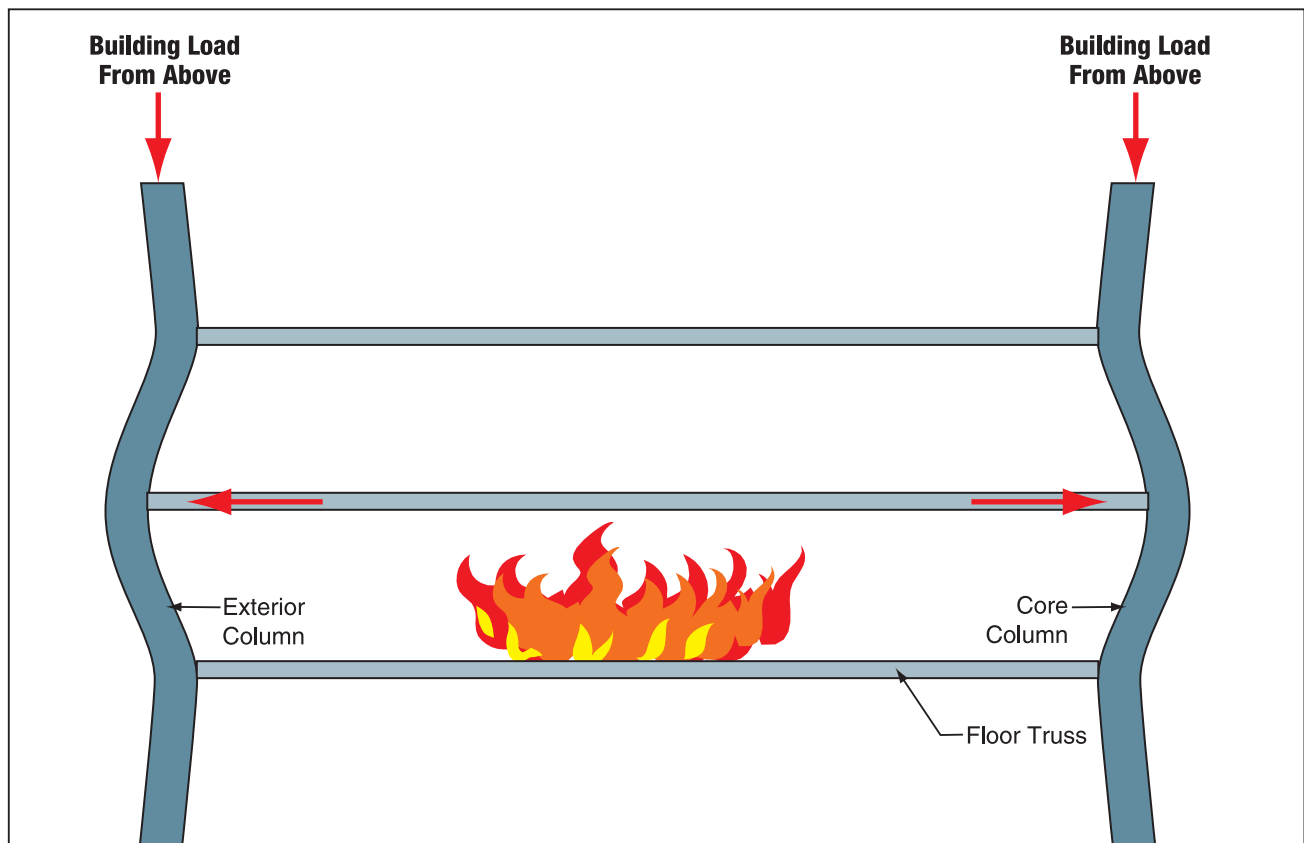
Figure 2-20 Expansion of floor slabs and framing results in outward deflection of columns and potential overload.

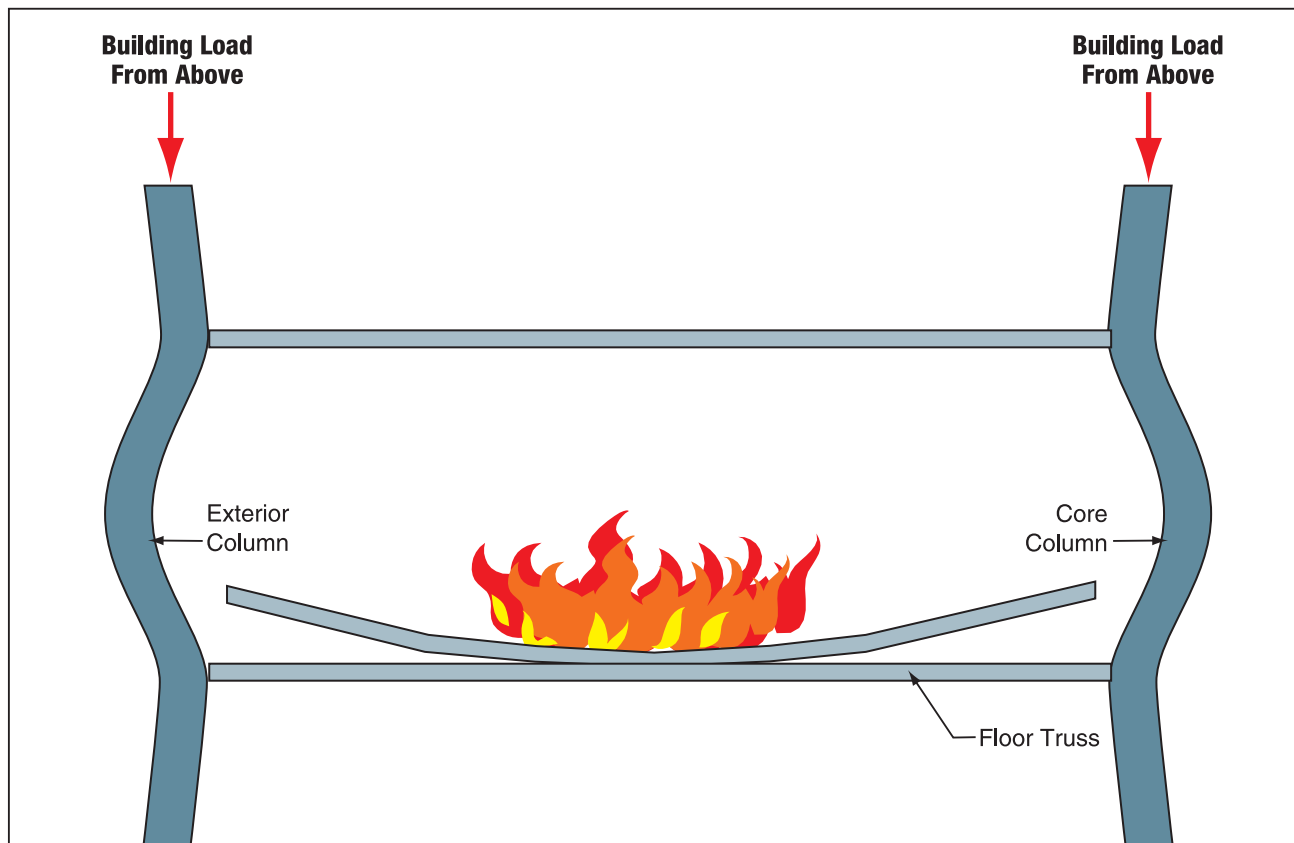
Figure 2-21 Buckling of columns initiated by failure of floor framing and connections.

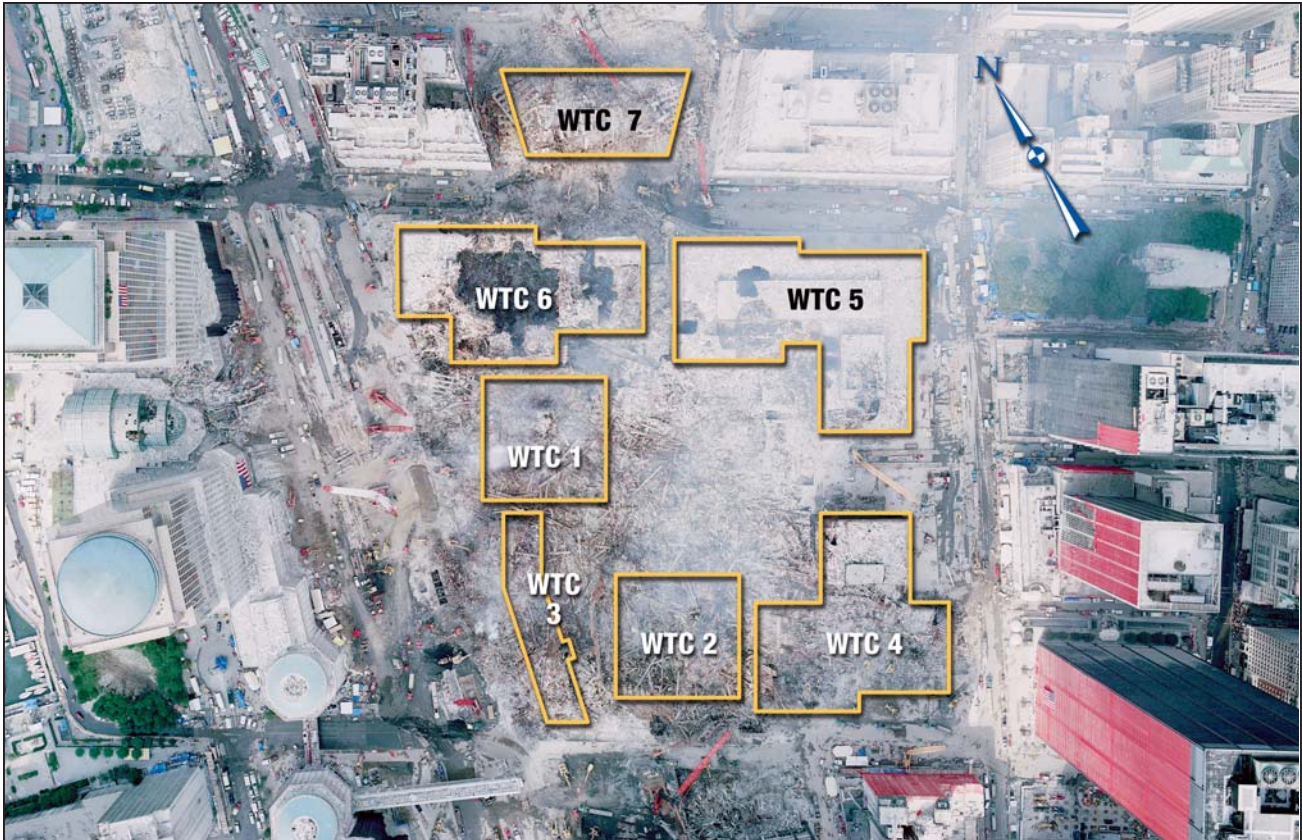
Figure 2-23 Aerial photograph of the WTC site after September 11 attack showing adjacent buildings damaged by debris from the collapse of WTC 1.

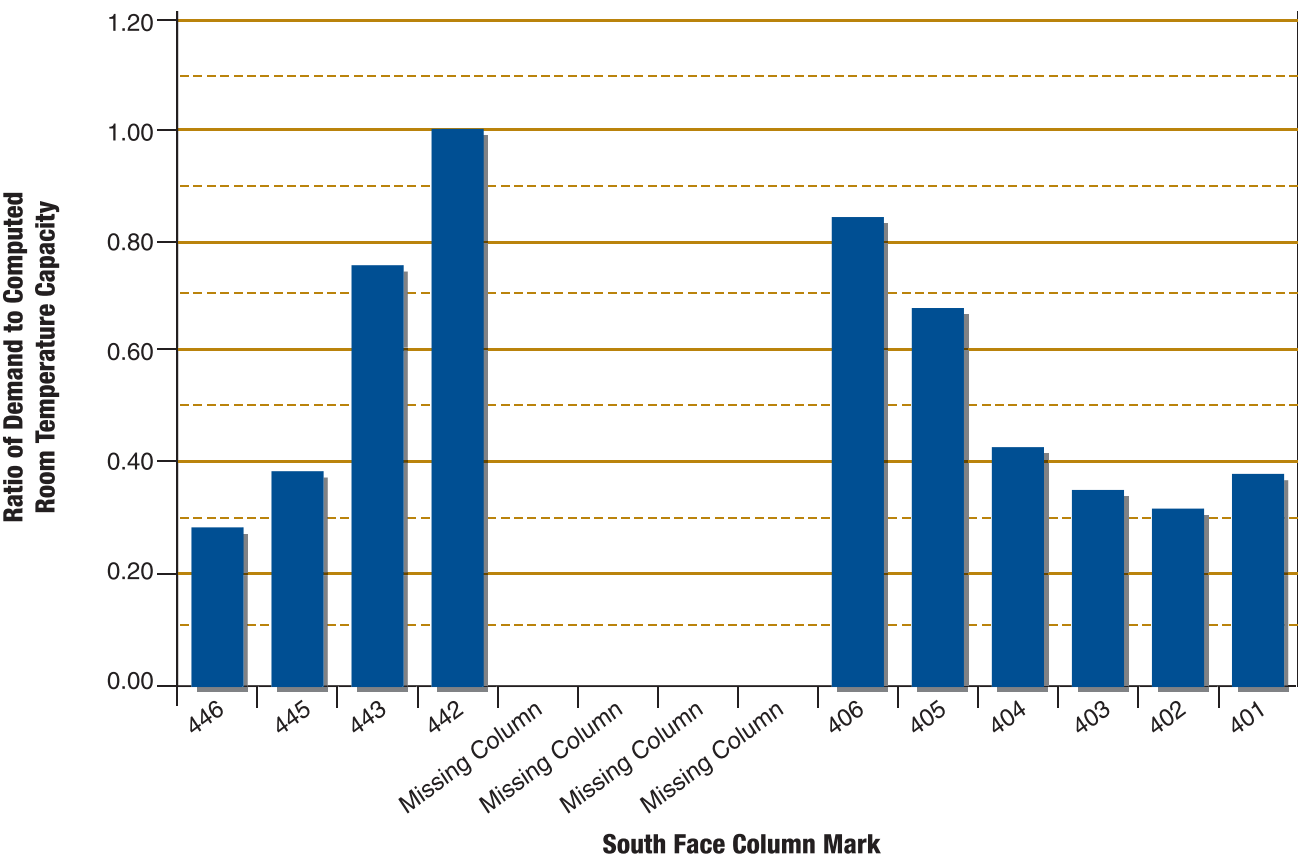
Figure 2-31 Plot of column utilization ratio at the 80th floor of WTC 2, viewed looking outward. (Conservatively assumes columns 407–411 and 440–441 to be missing.)

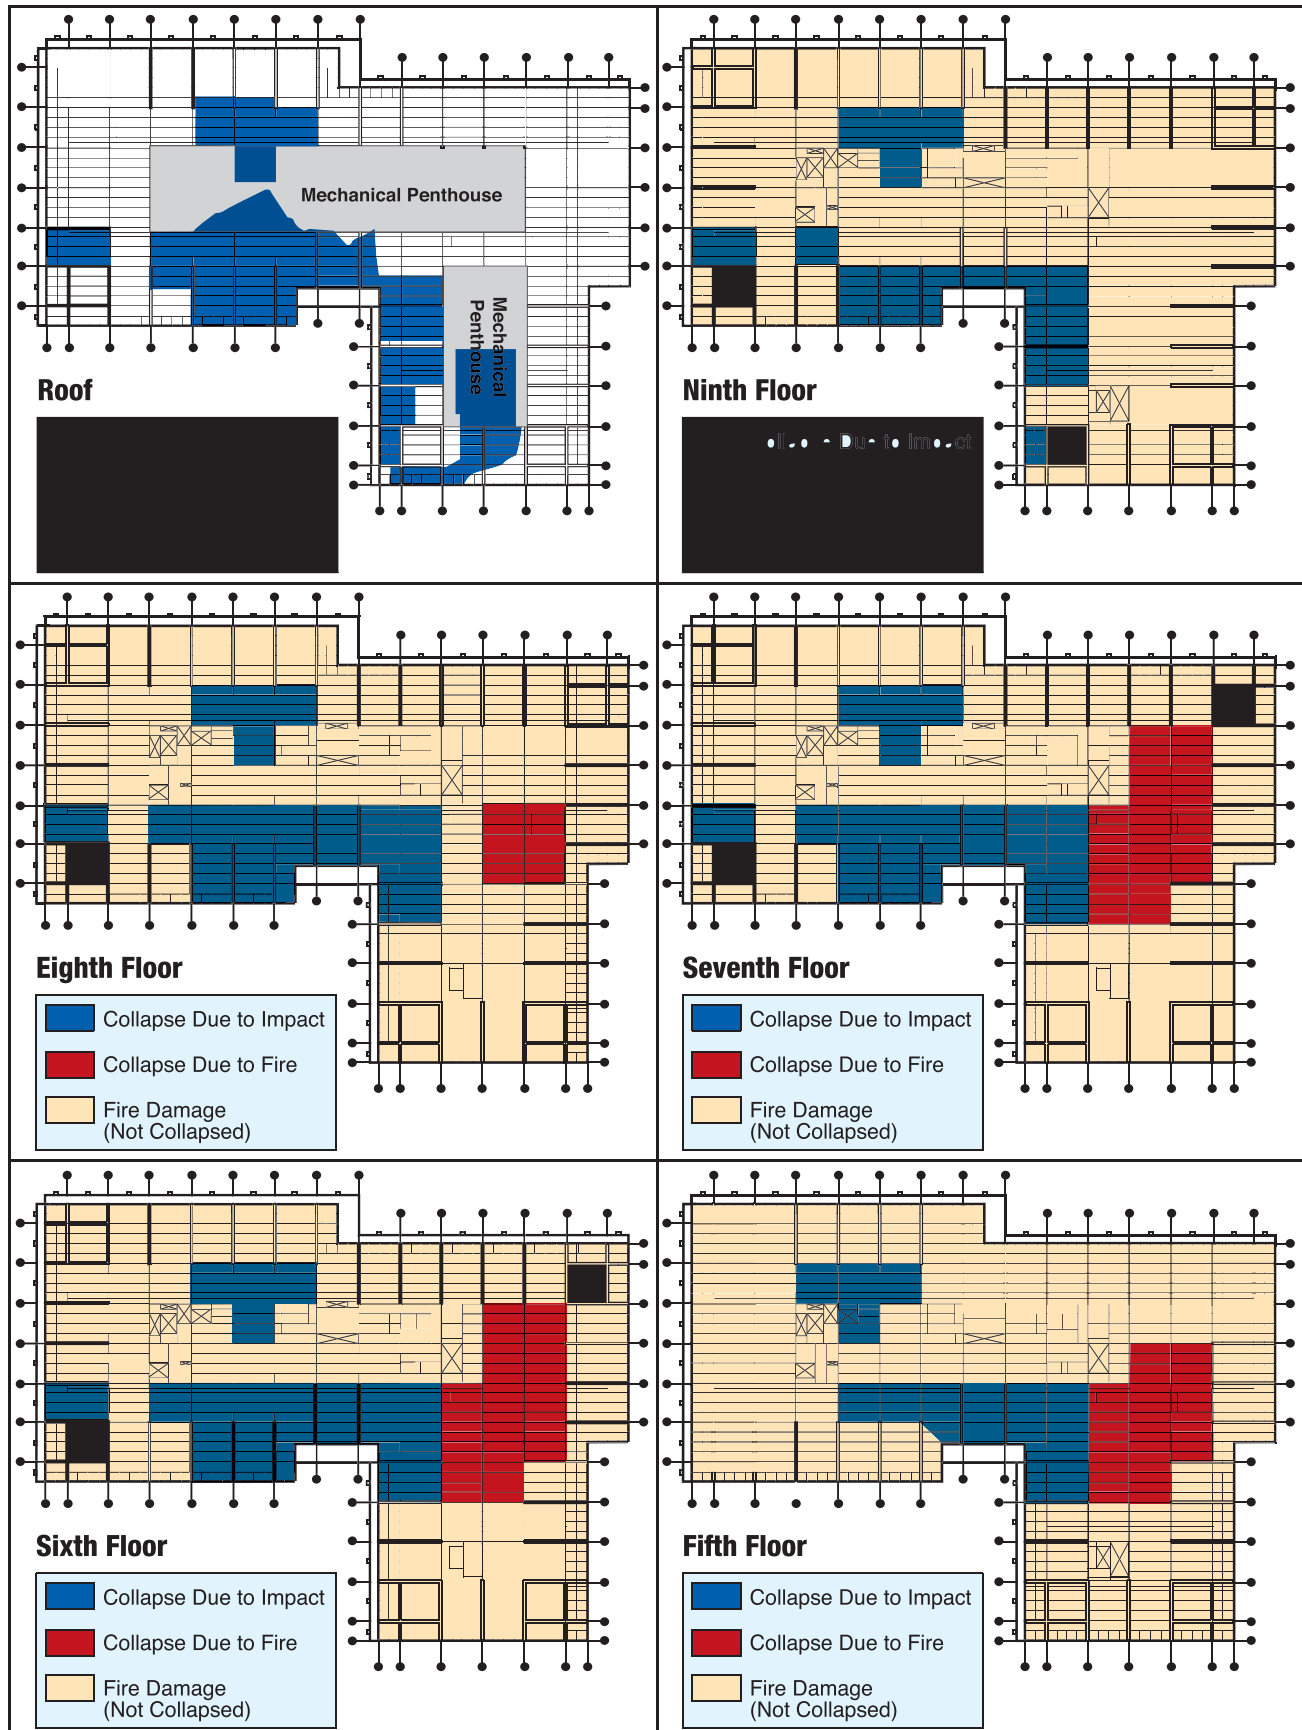
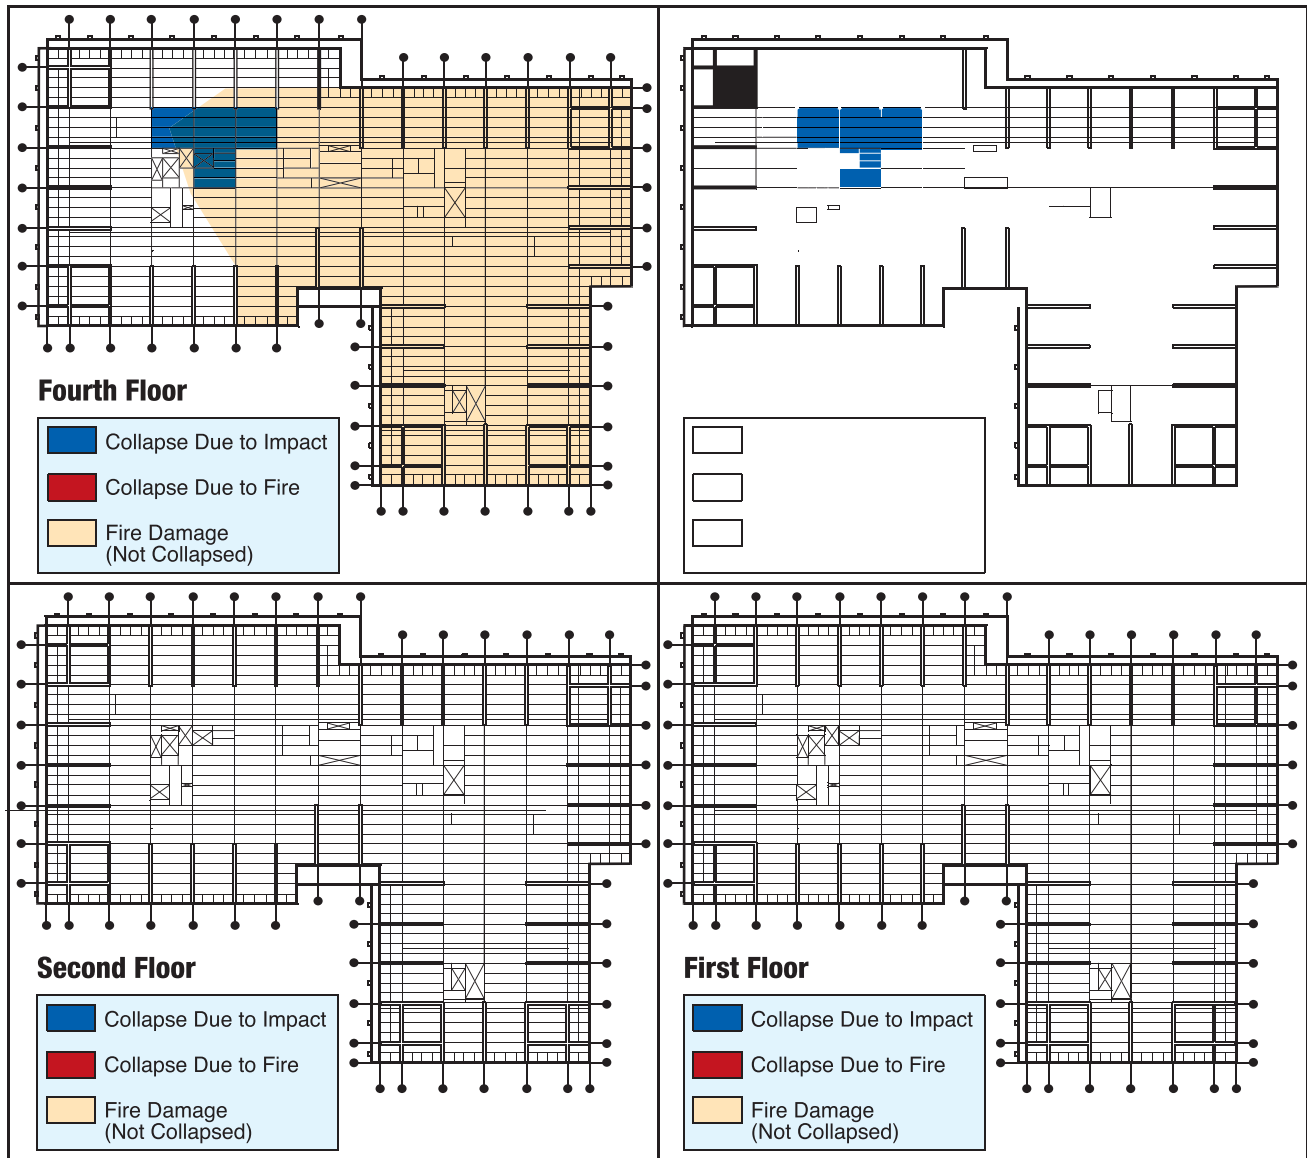
WTC 5 was damaged by impact and subsequent fires. The impact damage areas in WTC 5 are shown in Figure 4-6. The debris damage caused localized collapses from the roof to the 3rd floor in most of the areas where exterior columns impacted the structure. Ensuing fires that burned unchecked in the building caused a localized collapse from the 9th floor to the 4th floor. Figure 4-7 diagrammatically shows the damaged and collapsed areas of WTC 5 due to impact and fire.

Figure 4-7 Approximate locations of damaged floor areas in WTC 5.

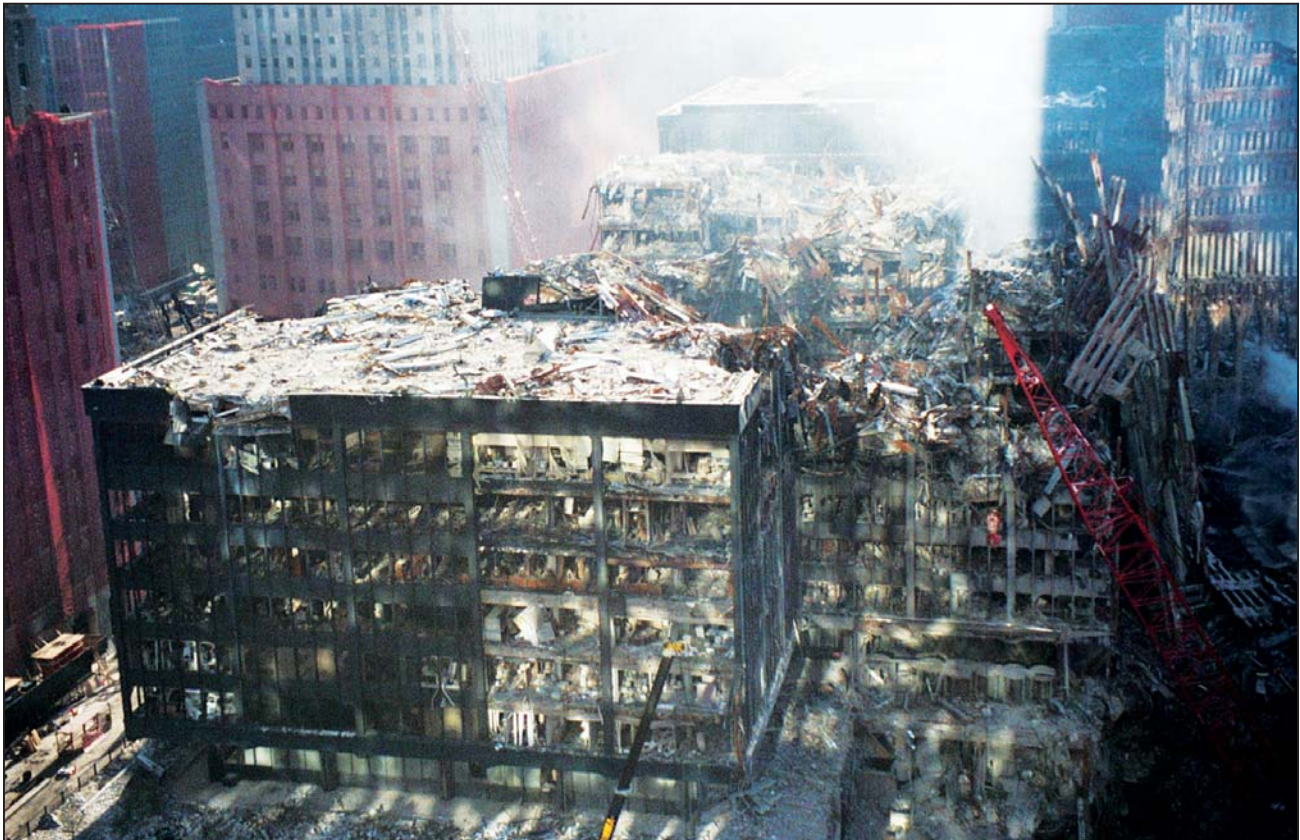
Figure 4-9 Impact damage to WTC 6.

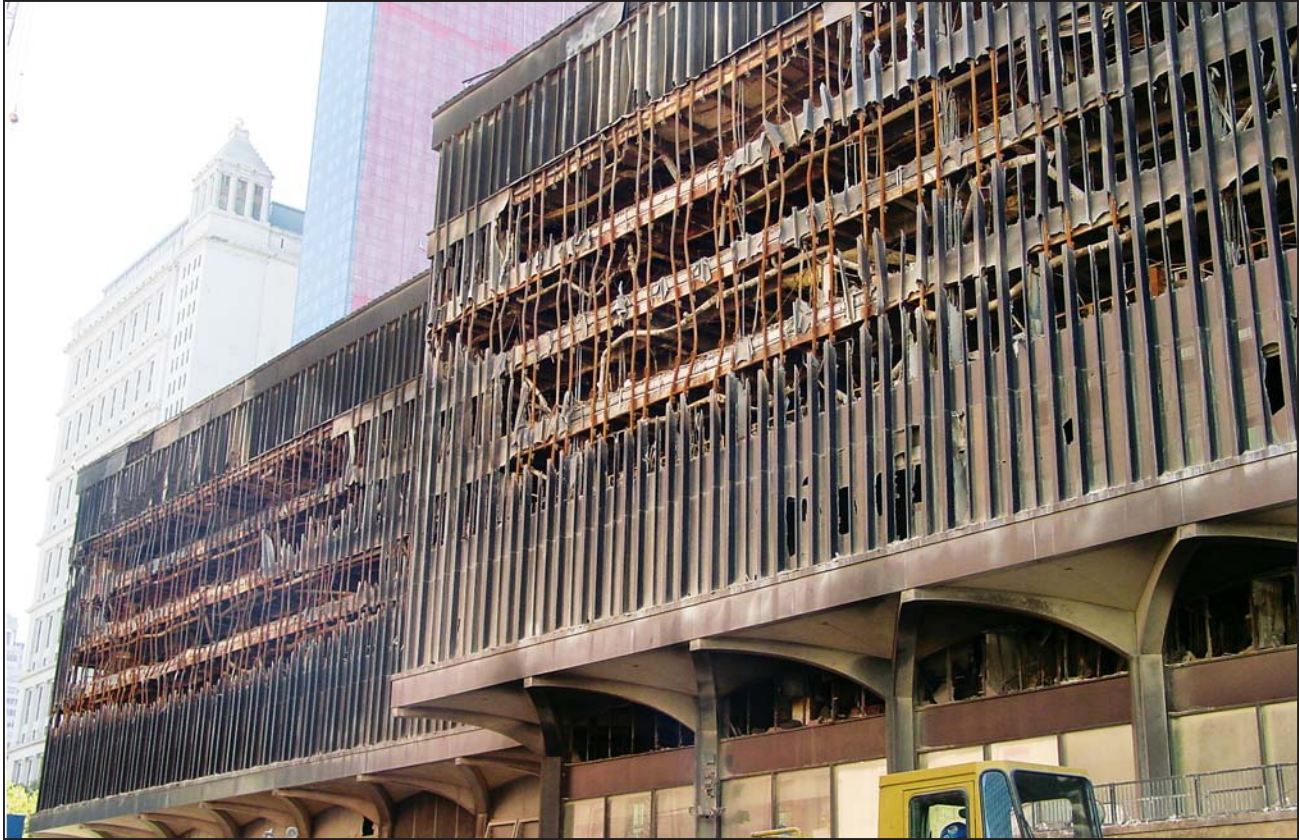
Figure 4-11 WTC 5 façade damage.

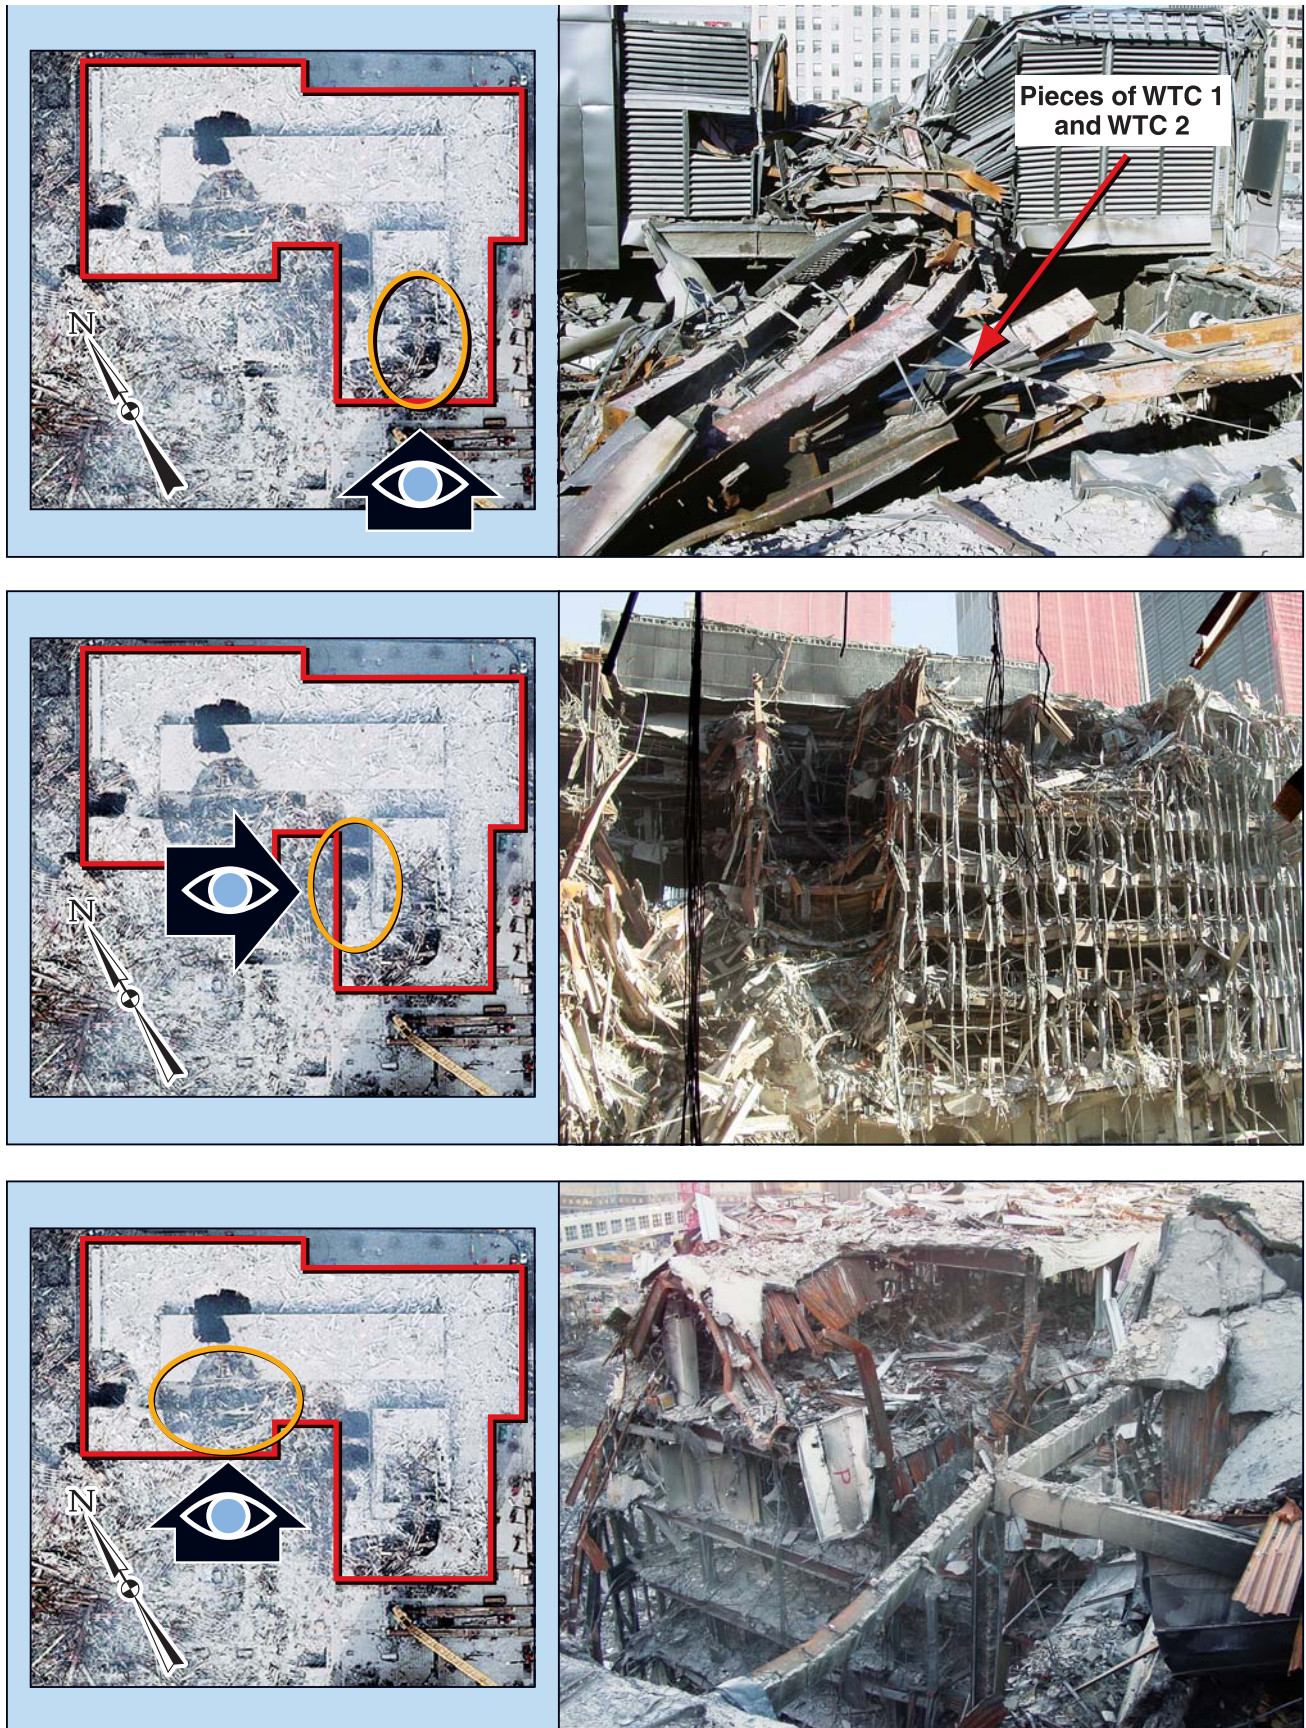
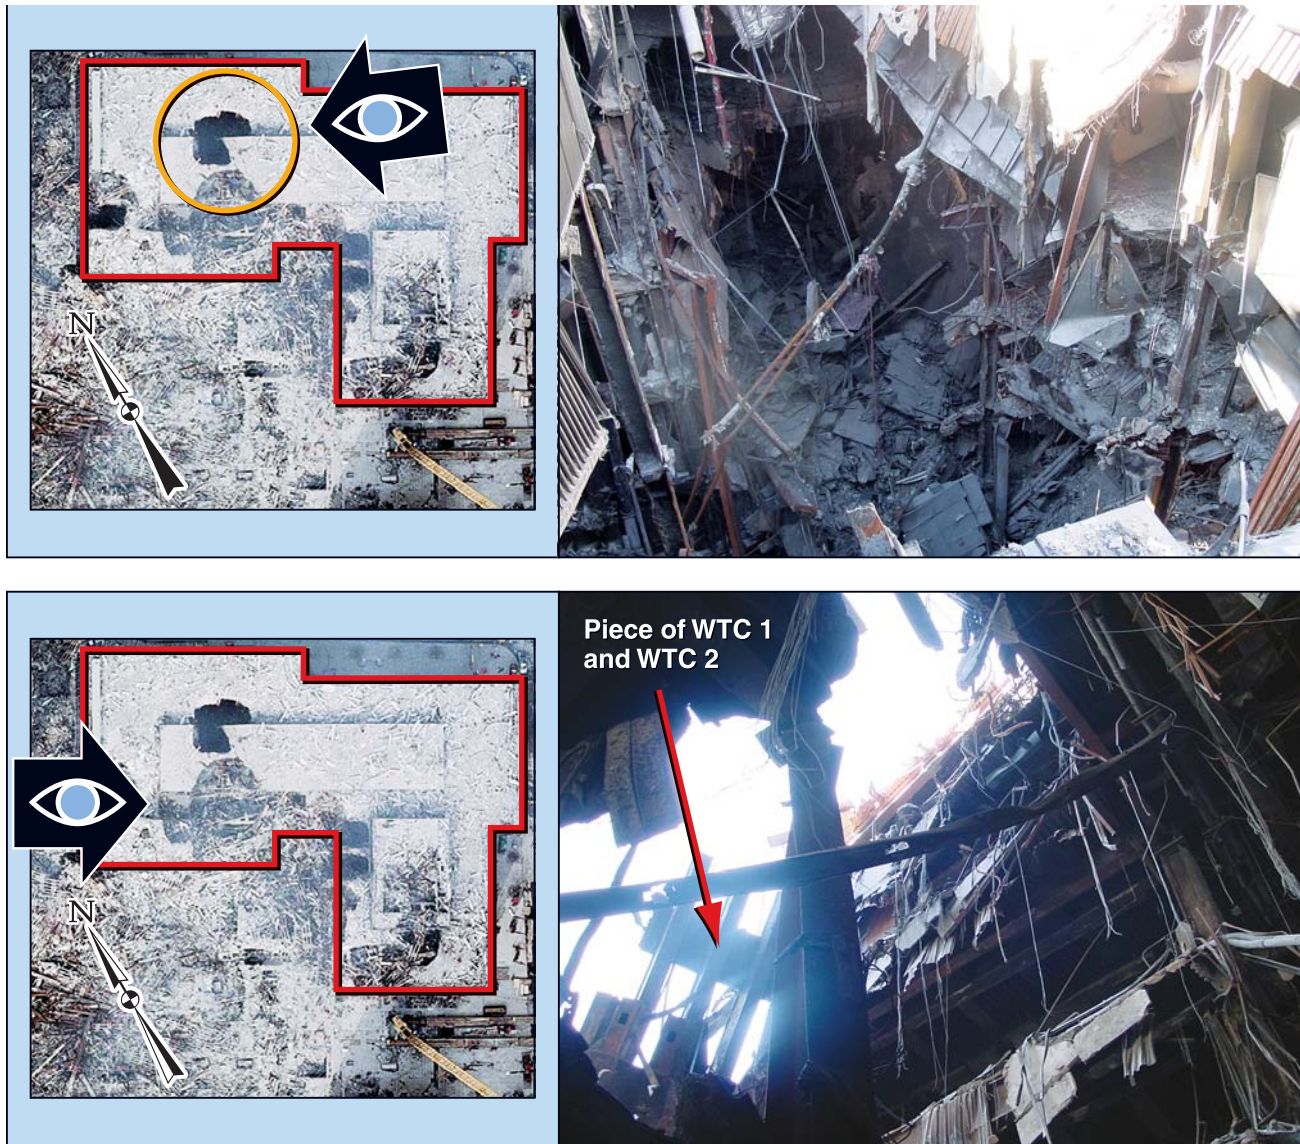
The debris from the towers caused damage to the outside wall steel framing of WTC 5, but this damage did not cause any additional collapse of the floors. In fact, the steel pipe façade supports (mullions) provided structural redundancy to the floor framing and redistributed some portion of the cantilevered floors to other levels.

Figure 4-12 Impact damage to WTC 5.

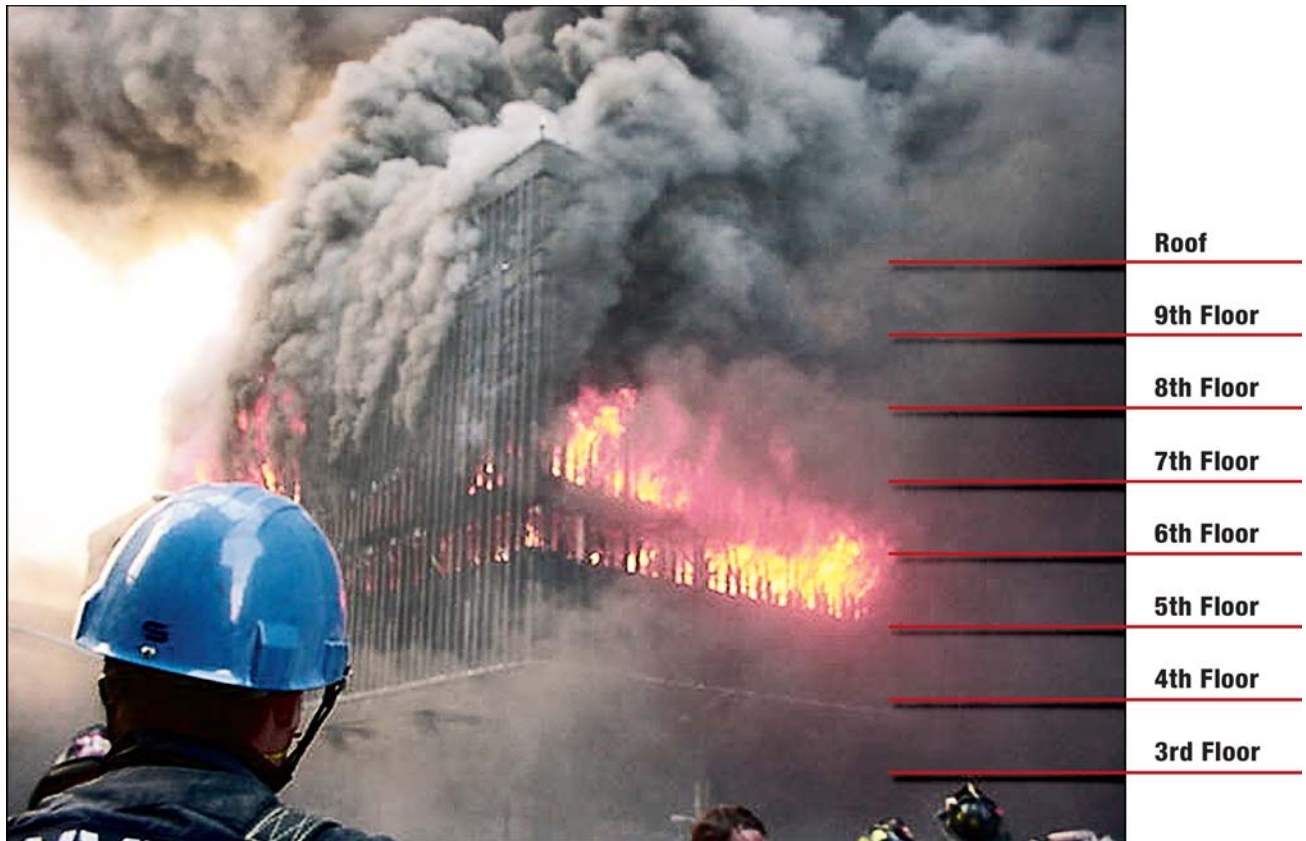
Figure 4-13 WTC 5 on fire.

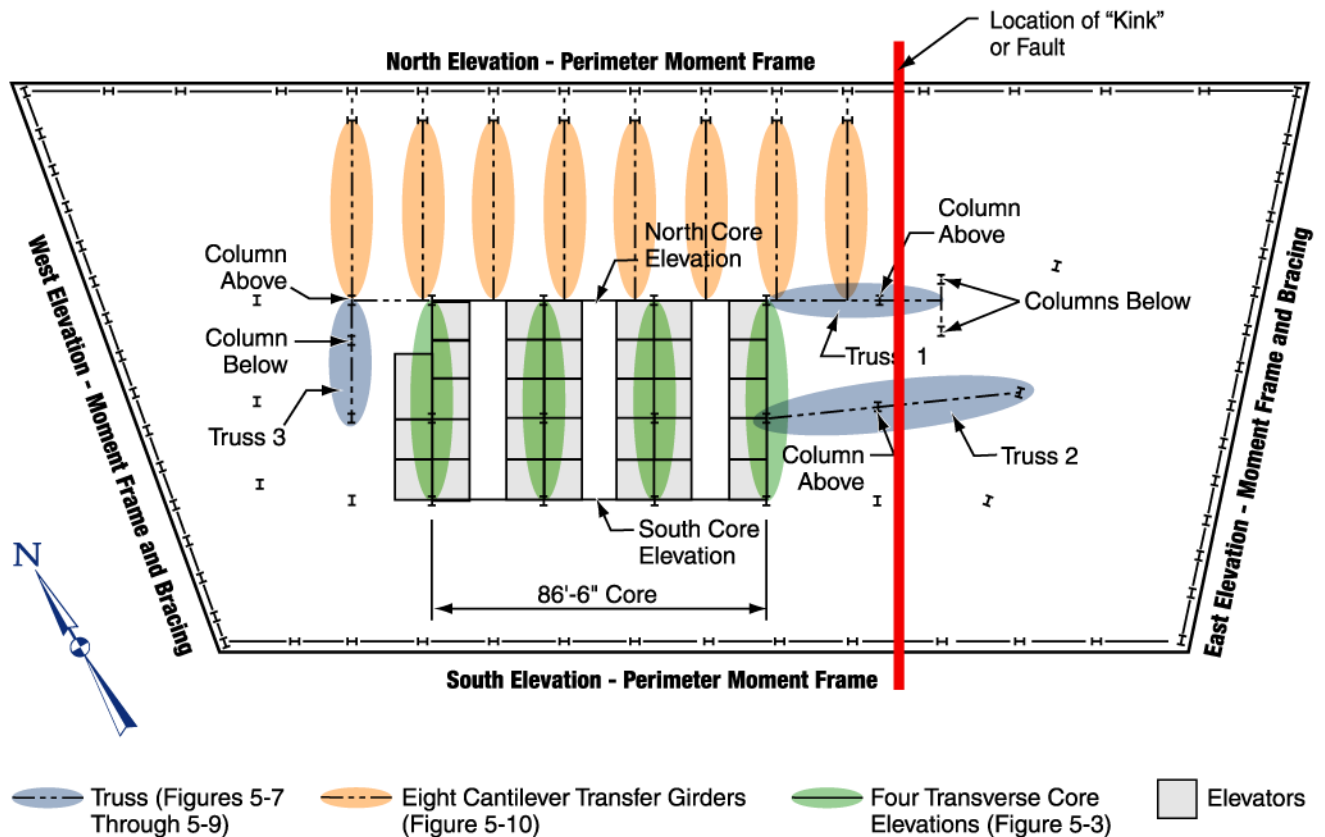
4th Floor Scenarios. The bottom cords of the transfer trusses were part of the support of the 5th floor slab and, as such, were located below the slab and above the ceiling of the 4th floor in a position exposed to fire from below. The bottom cord members were massive members weighing slightly over 1,000 pounds per foot. Such members are slow to heat up in a fire. It was reported that these bottom cords were fireproofed. The space below was the cafeteria dining room. The best information available indicates that the dining room was furnished with tables and chairs. The intensity and duration of a fire involving these furnishings would not be expected to sufficiently weaken either the trusses or the columns supporting the trusses. Member collapse as a result of a fire on the 4th floor would require either that there was significant additional fuel or that the fireproofing on the trusses or columns was defective. Fuel oil leakage from the 5th floor is also a possibility; however, no evidence of leakage paths in the east end of the second floor was reported.

Figure 5-24 Areas of potential transfer truss failure.

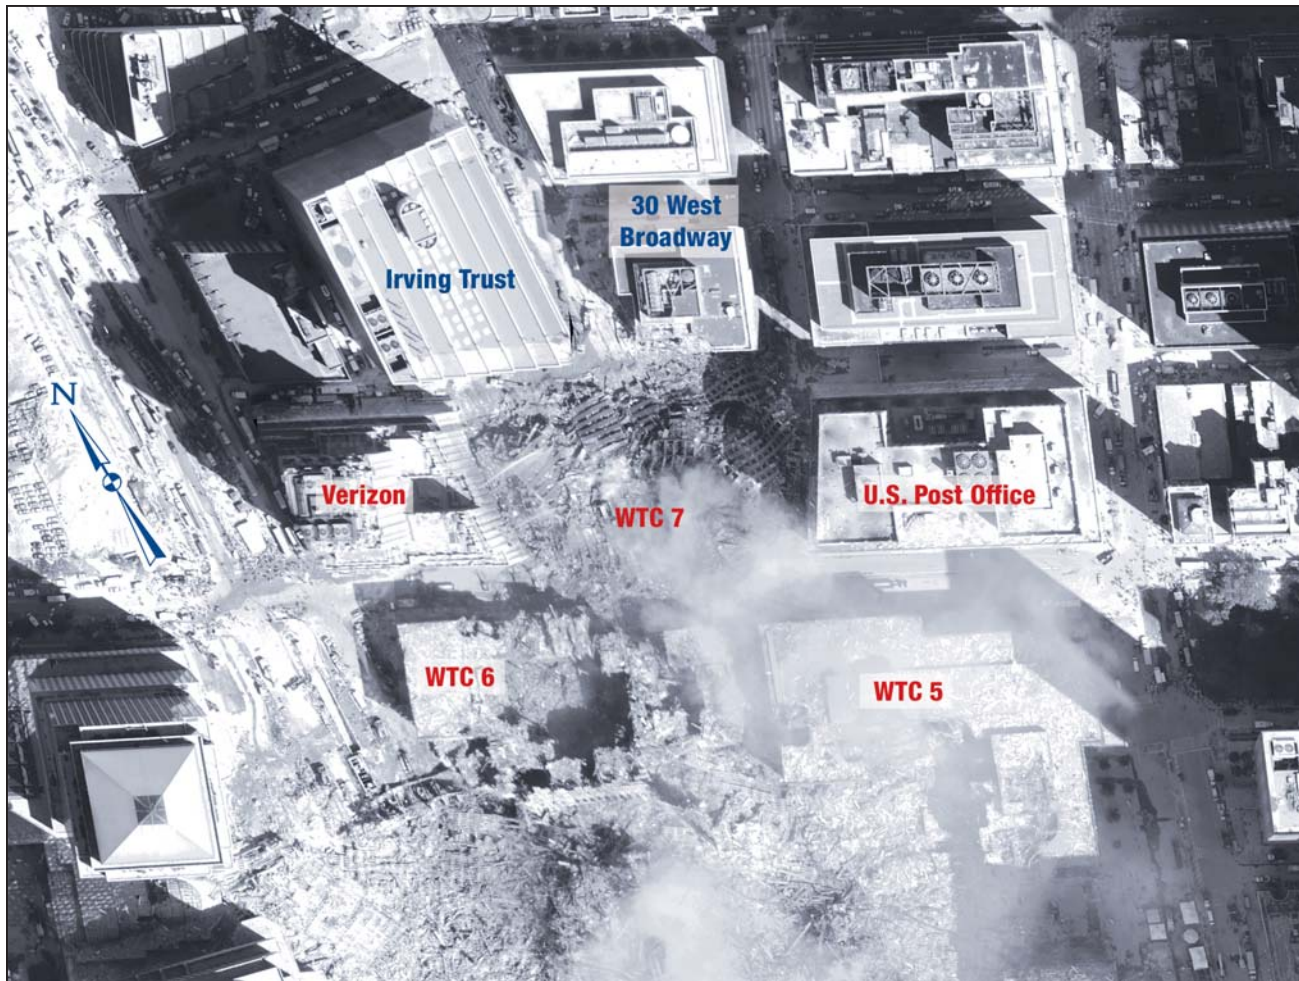
Figure 5-26 Debris generated after collapse of WTC 7.

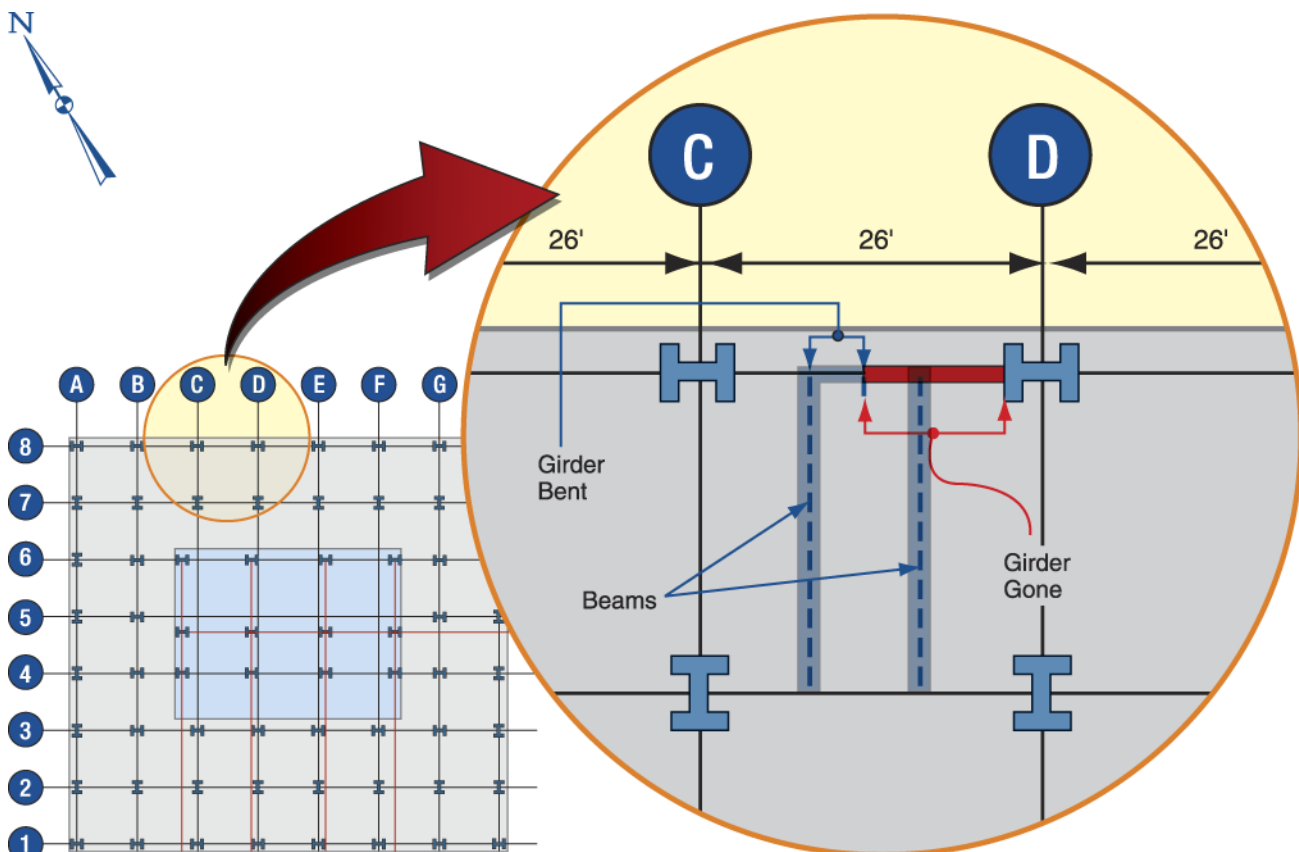
Figure 6-4 Area of initial impact of debris at the 23rd floor.
